FHWA-CA-2153-77-10

Correlation Of The Seismic Velocity Of Rock To The Ripping Ability Of The HD41 Tractor

April 1977

Office of Transportation Laboratory  
California Department of Transportation  
Sacramento, California 95819

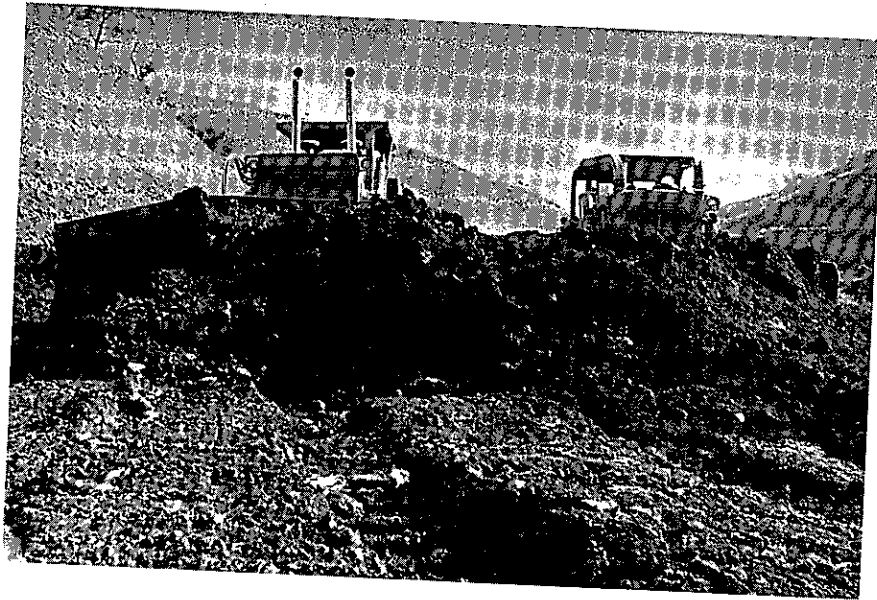
Figure 1. Front view of the two tractors, HD41 on the left, D9G on the right.

To appreciate the size of the HD41, it is necessary to compare it to the Caterpillar D9G. The latter has a working weight of 100,000 pounds (45,400 Kg) and a 385 horsepower engine, whereas the HD41 has a working weight of 155,000 pounds (68,000 Kg) and a 524 horsepower engine. The relative sizes of the two tractors are shown in Figures 1 and 2.

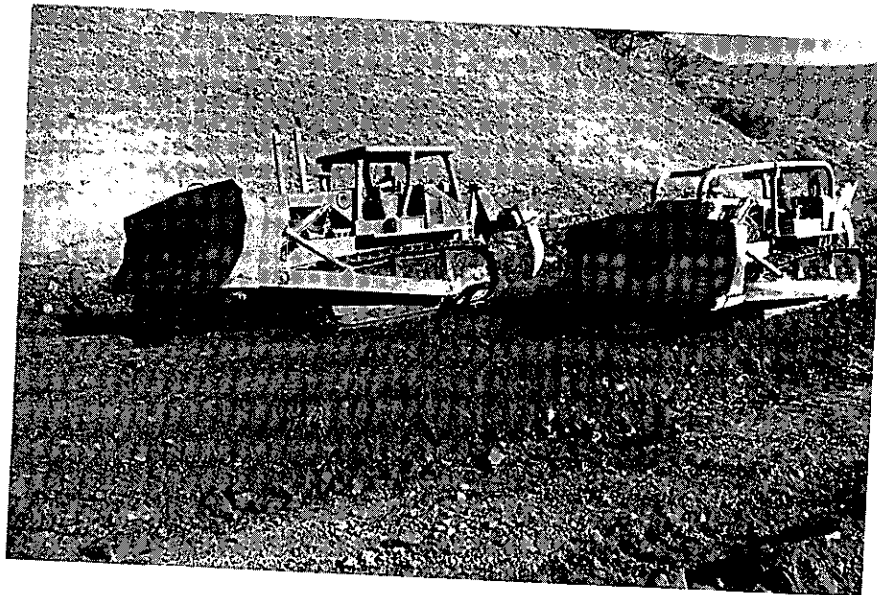
Figure 2. Side view of the two tractors. HD41 with double tooth ripper on the left, D9G with single tooth ripper on the right.

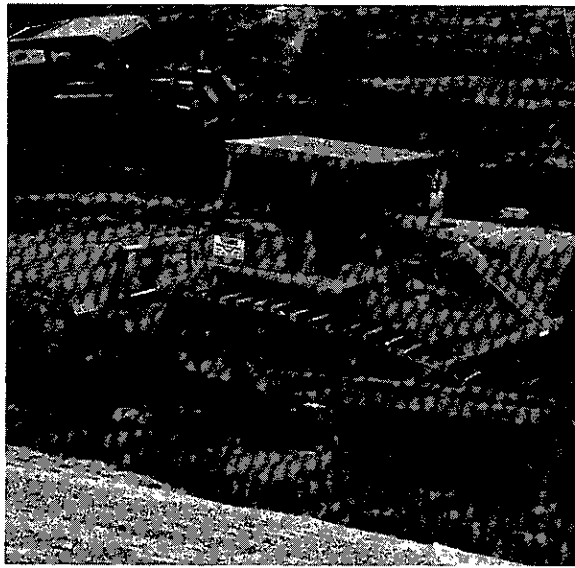
Figure 8. D9G Ripping granitic rock with a single four foot (1.2 m) tooth near Sta 328. Note that tractor is on "tiptoe", and tooth is not fully in ground, 08-Riv-60.

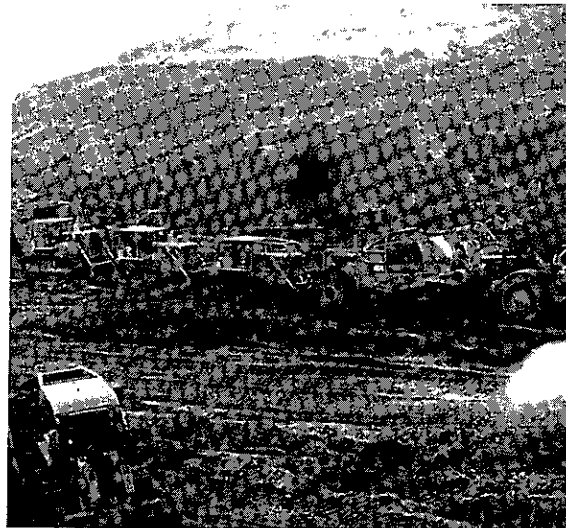
Figure 9. Scraper spread in operation. Three D9G pusher tractors are loading scraper. D9G, equipped with two-three foot (.9m) teeth and a slopeboard, operating in foreground, 08-Riv-60.
